# CHRIS WITOR.com

Mk II Inlet port section pre 219016

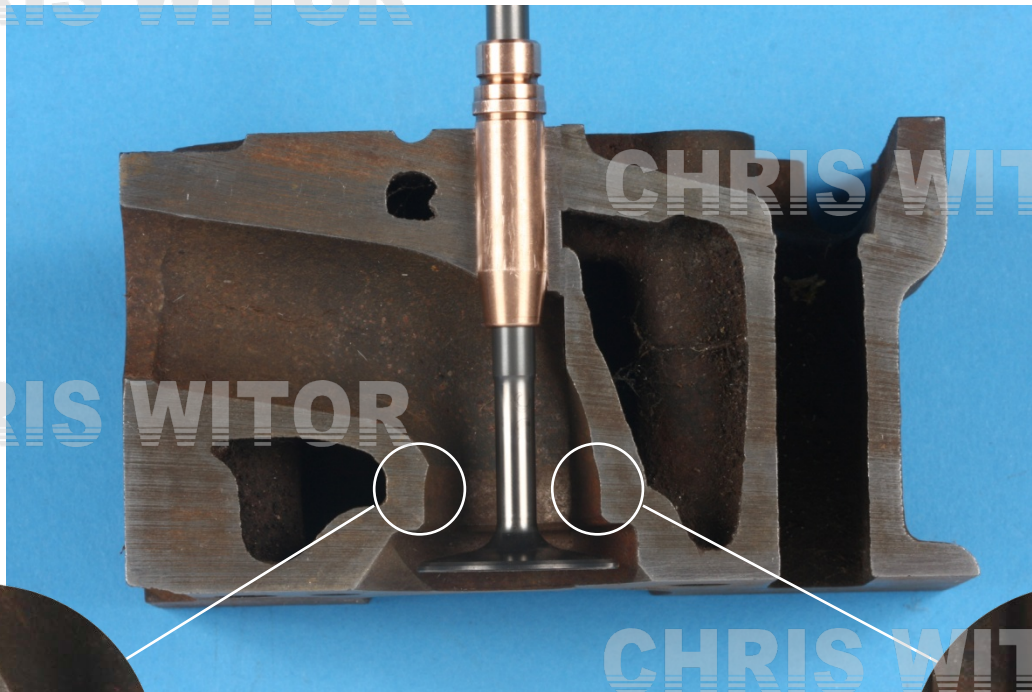
Pre 219016 lack material here, turning flow into the valve rather than into the combustion chamber resulting in a 10 cfm loss of flow at .500" valve lift
